# Seismic Fragility of Suspended Ceiling Systems

Hiram Badillo-Almaraz,<sup>a)</sup> Andrew S. Whittaker,<sup>b)</sup> M.EERI,  
and Andrei M. Reinhorn,<sup>c)</sup> M.EERI

Full-scale dynamic testing of suspended ceiling systems was performed to obtain fragility data suitable for performance-based assessment and design. On the basis of the fragility data derived from testing, (1) the use of retainer clips improves the performance of ceiling systems in terms of loss of tiles, (2) including recycled cross tees in the suspension grid increases the vulnerability of the ceiling systems, (3) undersized (poorly fitting) tiles are substantially more vulnerable than properly fitted tiles, and (4) the use of compression posts improves the seismic performance of ceiling systems for the limit states of minor and moderate damage. Fragility curves are provided for four damage states. [DOI: 10.1193/1.2357626]

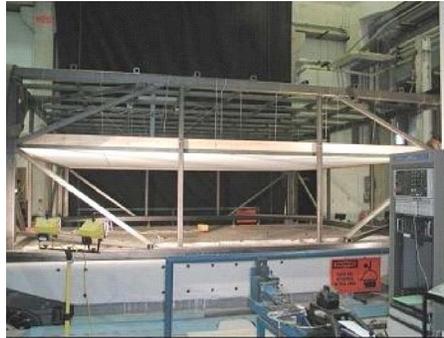
A 4.88-m  $\times$  4.88-m (16-ft  $\times$  16-ft) square test fixture of ASTM Grade 50 steel was constructed to test the ceiling systems. A 3.8-cm  $\times$  3.8-cm (1-1/2-in.  $\times$  1-1/2-in.) angle was welded around the perimeter of the test fixture; a 5.1-cm  $\times$  15.2-cm (2-in.  $\times$  6-in.) timber ledger was attached to the angles to laterally restrain the ceiling system. The test fixture was designed to simulate one story and one bay of a building with ver-

**Figure 1.** Test fixture mounted on the simulator at the University at Buffalo.

tical floor frequencies in the range of 9 Hz to 12 Hz and horizontal frequencies in the range of 10 Hz to 16 Hz. Badillo (2003) and Badillo et al. (2006) provide a detailed description of the test fixture. Figure 1 is a photograph of the test fixture installed on the Buffalo simulator.

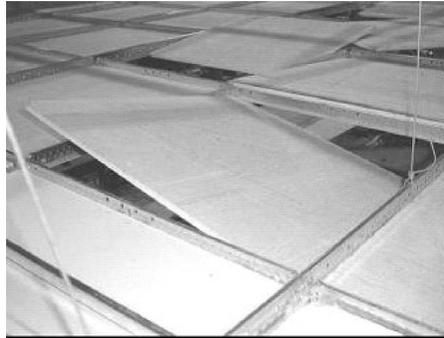
**Figure 7.** Tile rotating before falling, configuration 1.

The undersized tiles generally failed after popping up and out of the suspension grid. If the tiles did not fall back into their original position in the grid, the tiles typically rotated about their points of contact with the grid and fell to the simulator platform. Figure 7 shows a tile the instant in time before it fell from the suspension grid.

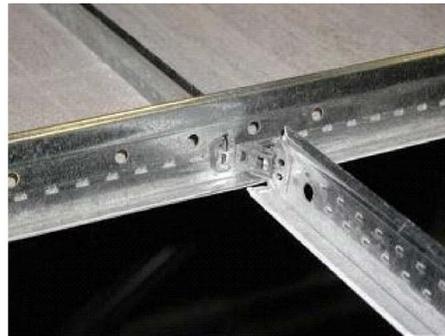
(a) Buckling in 4-ft cross tees

(b) Damage to the latches

**Figure 8.** Damage to the cross tees when retainer clips were included in the ceiling system. (a) Buckling in 4-ft cross tees; (b) Damage to the latches.

taining the tiles, the clips increased the inertial loads on the grid, resulting in grid damage at lower levels of shaking. Figure 8a shows a buckled 1.22-m (4-ft) cross tee following a combined horizontal and vertical shaking test to  $S_S$  equal to 2.5 g. Another example of damage to the grid components is presented in Figure 8b, where the latches of the cross tees are shown bent and broken. In the three configuration 2 systems, tiles were lost primarily due to failure of grid components.

- The use of retainer clips substantially improved the behavior of the suspended ceiling systems in terms of loss of tiles. However, by retaining the tiles, the use of clips increased the inertial loads on the grid, resulting in grid damage at lower levels of shaking. The loss of tiles in systems with retainer clips was due primarily to the failure of grid components. Alternate strategies for retaining ceiling tiles should be developed to alleviate concerns regarding the removal of clips during above ceiling maintenance of mechanical, electrical and plumbing systems.

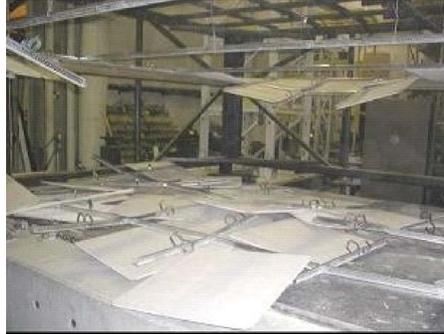
The damage produced by the unidirectional horizontal and vertical motions was minimal, concentrated in the components of the suspension grid. The retainer clips substantially improved the behavior of the ceiling systems in terms of loss of tiles by comparison with the systems of configuration 4, where clips were not included. The use of the retainer clips shifted the damage from the tiles to the suspension grid. The type of damage that was observed in the east-west 1.22-m (4-ft) cross tees of configuration 2 was also observed in the systems of configuration 5. In both systems, the loss of tiles was primarily due to the failure of components of the suspension grid. In one system (of four), a major failure in the suspension grid (see Figure 9), for combined shaking corresponding to  $S_S$  equal to 2.5 g, led to the loss of a considerable number of tiles.

**Figure 9.** Failure of grid and tiles in configuration 5.
